Assessment of Dam Safety

Coal Combustion Surface Impoundments (Task 3)

Final Report

JM Stuart Station

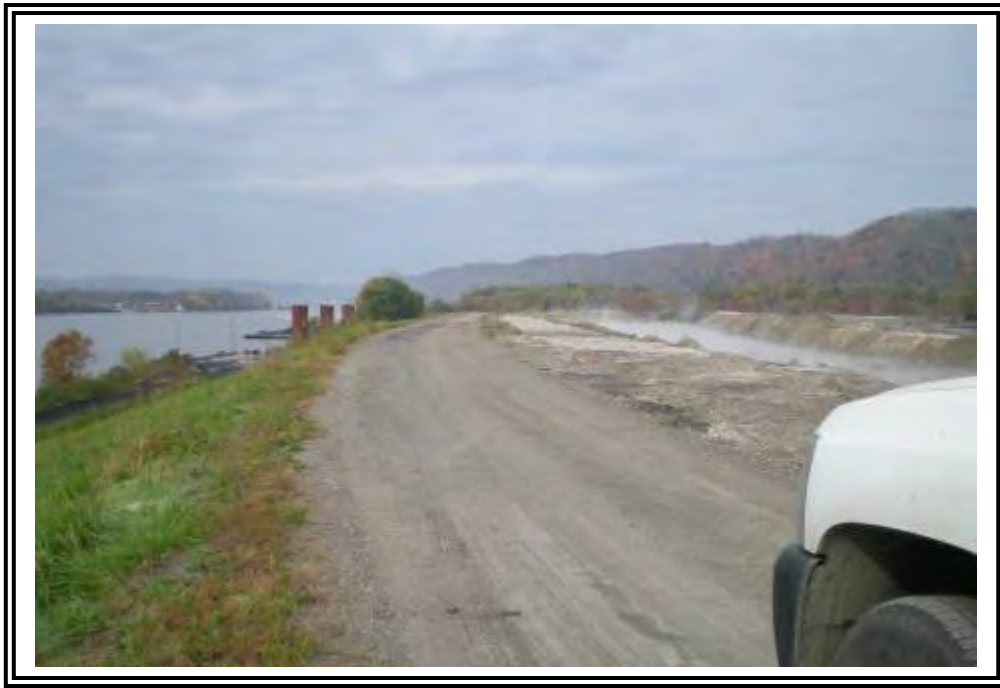
1

Looking west along the south dike of Pond 5. The Ohio River can be seen on left of photo.

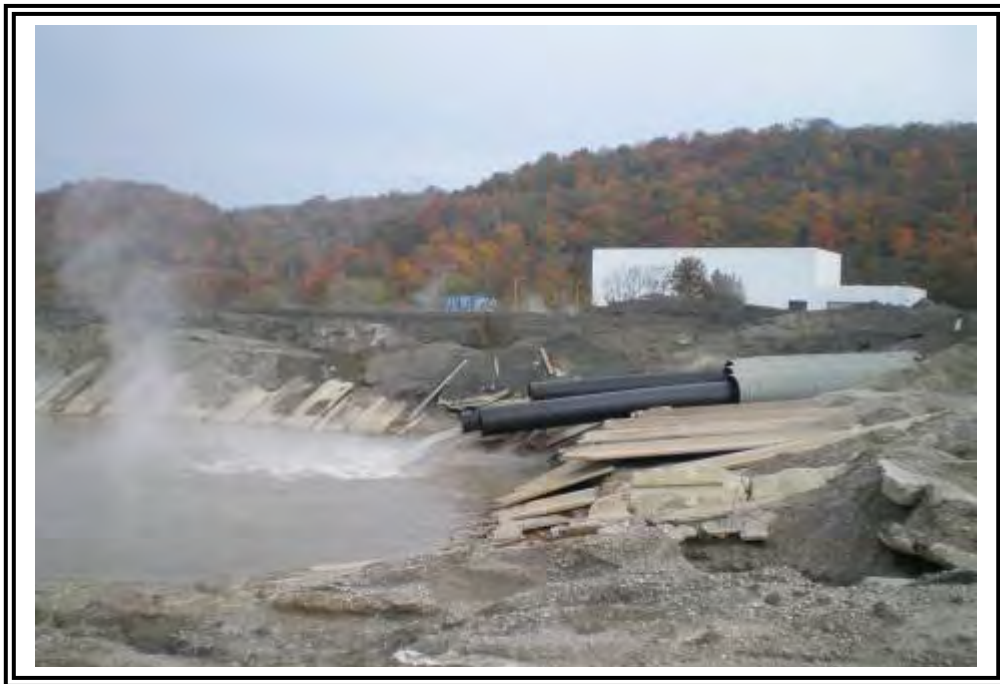
2

Looking north at the sluice lines coming into the pond.

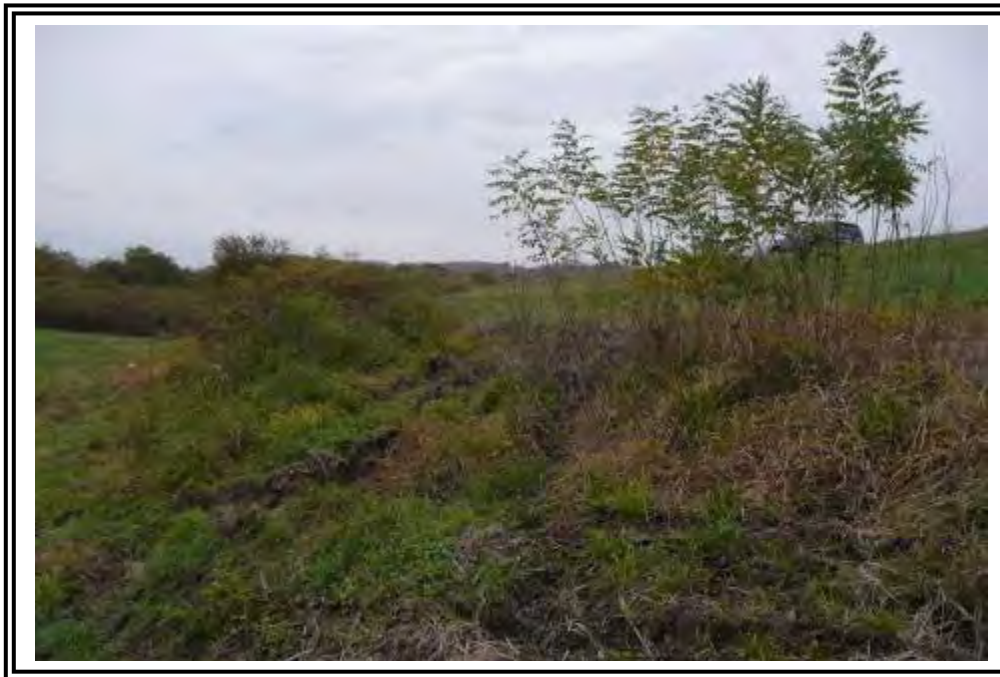
10

Seep softened and deformed area with denser vegetation on the downstream slope at the southwest end of the pond.

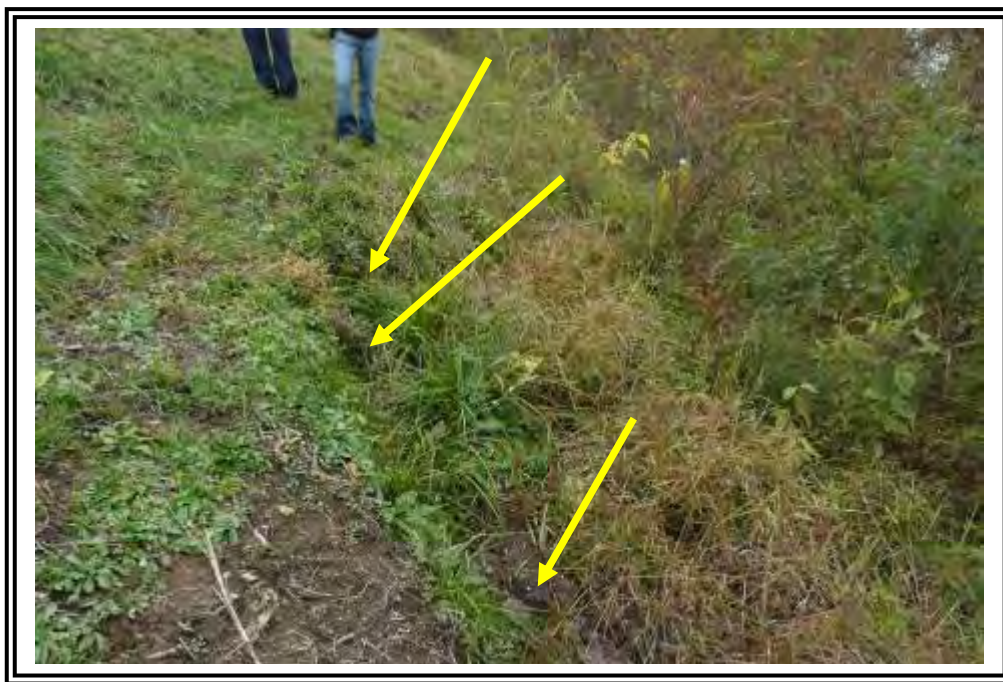
14

Vegetated scarp with standing water on west side of the pond. Approximately 30 feet long. (See arrows)

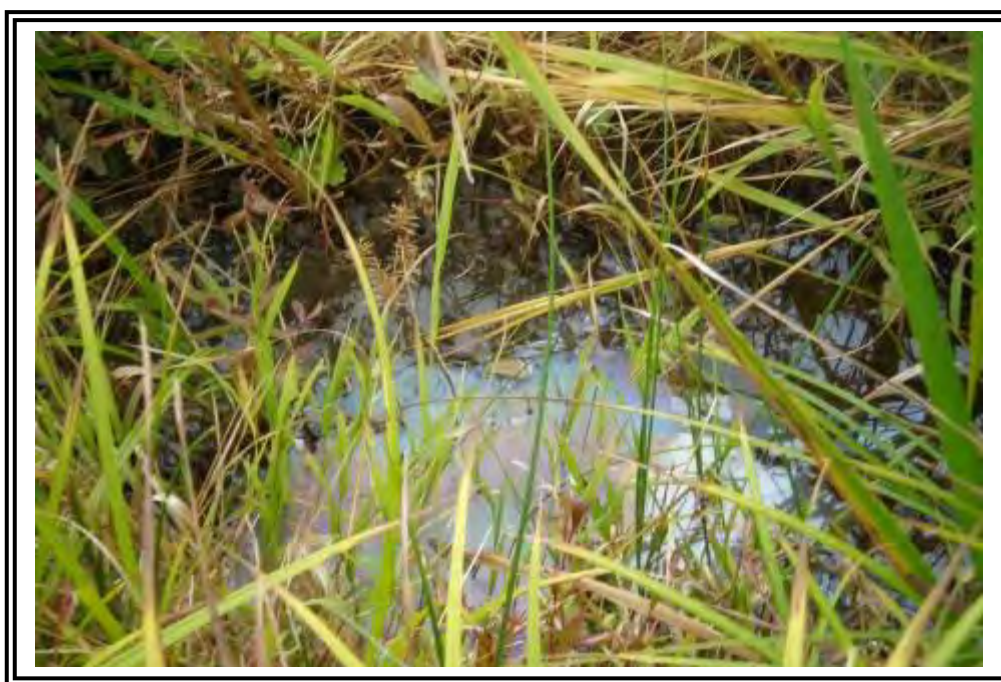
16

A close up of a larger seep with a sheen on the surface.

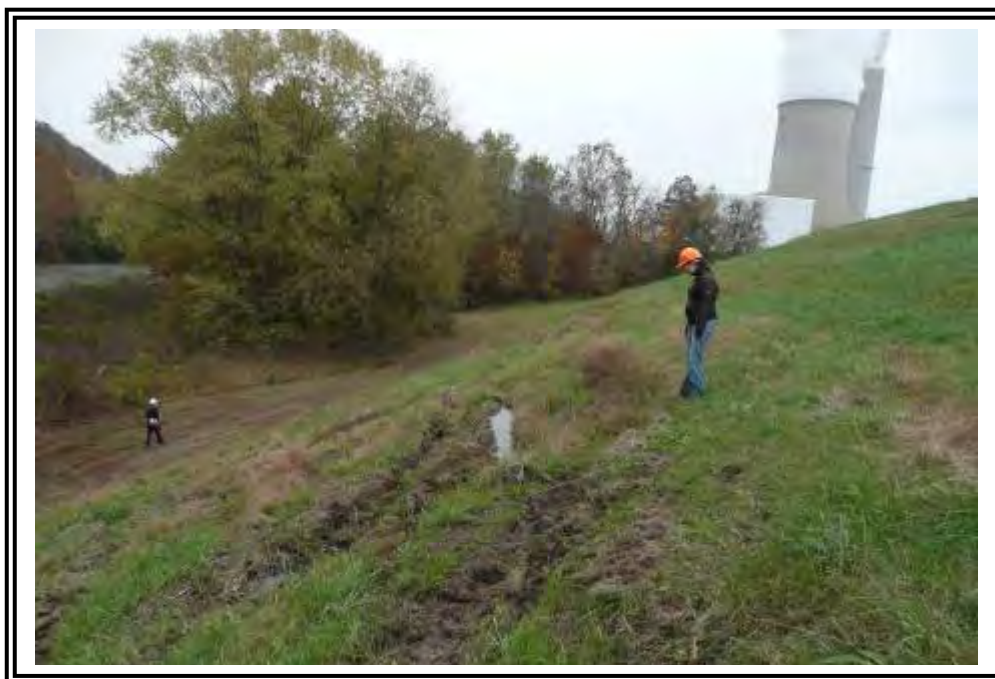
22

Looking east at the downstream slope of the northern dike near the middle of the pond where some seepage, subsequent softening, and slope deformation due to rutting has occurred.

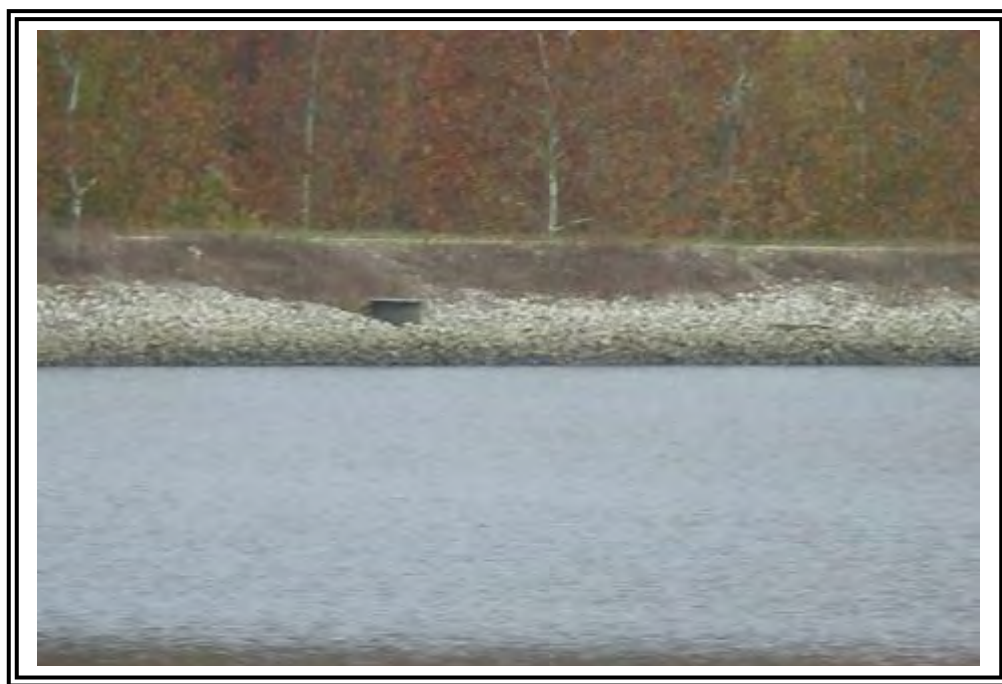
24

Looking north at the upstream slope of the northern dike showing more consistent, maintained riprap armoring.

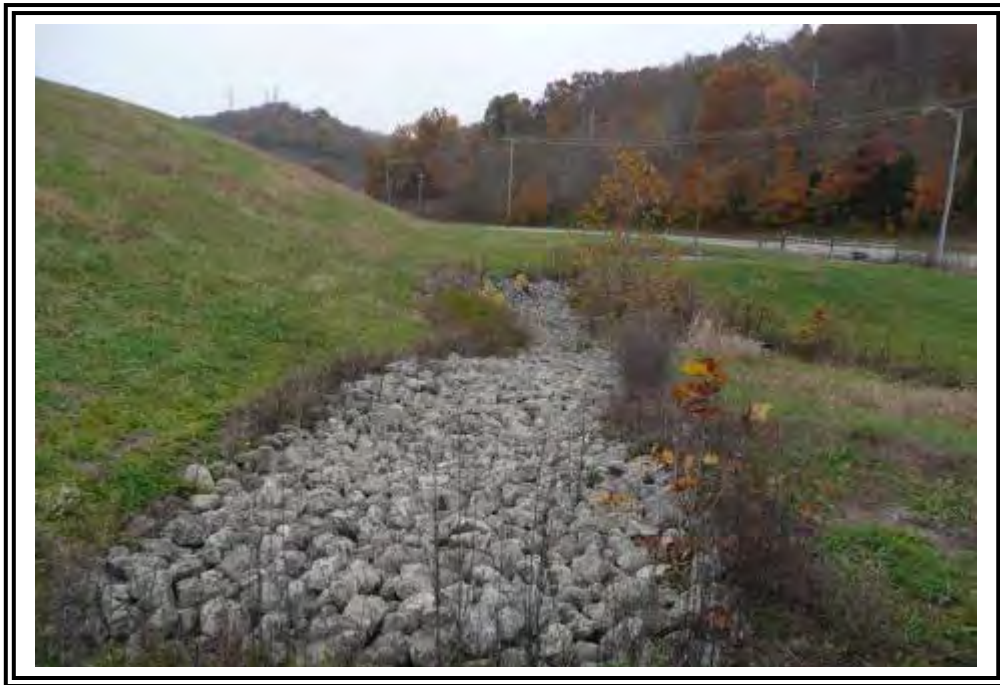
29

Looking northwest along the riprap drainage swale at the north tip of the pond.

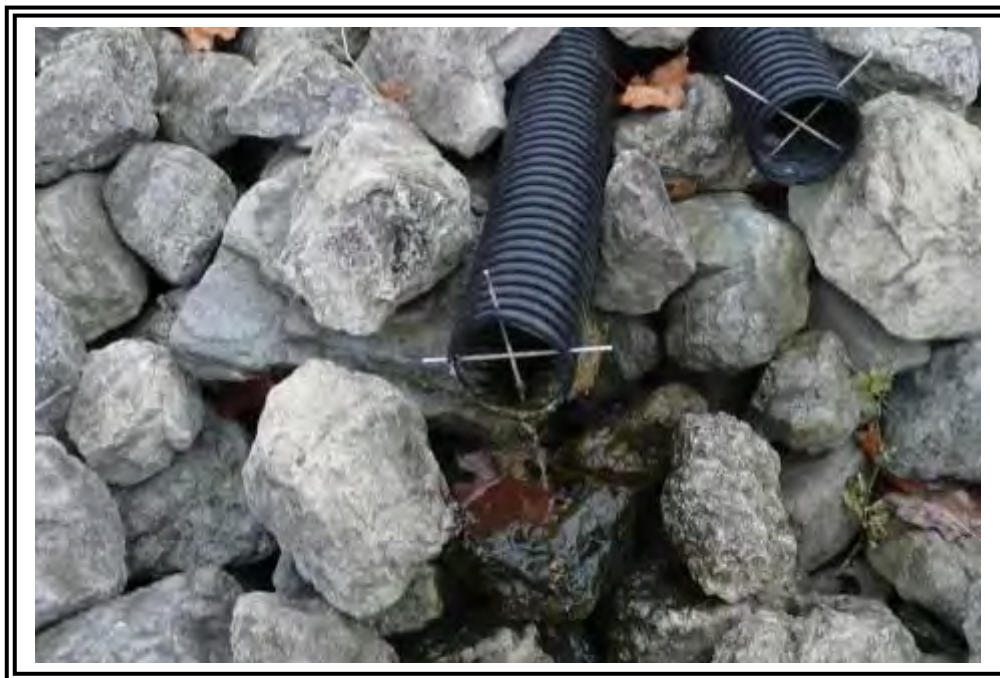
30

Close up of the drainage pipes that empty into the riprap drainage swale.

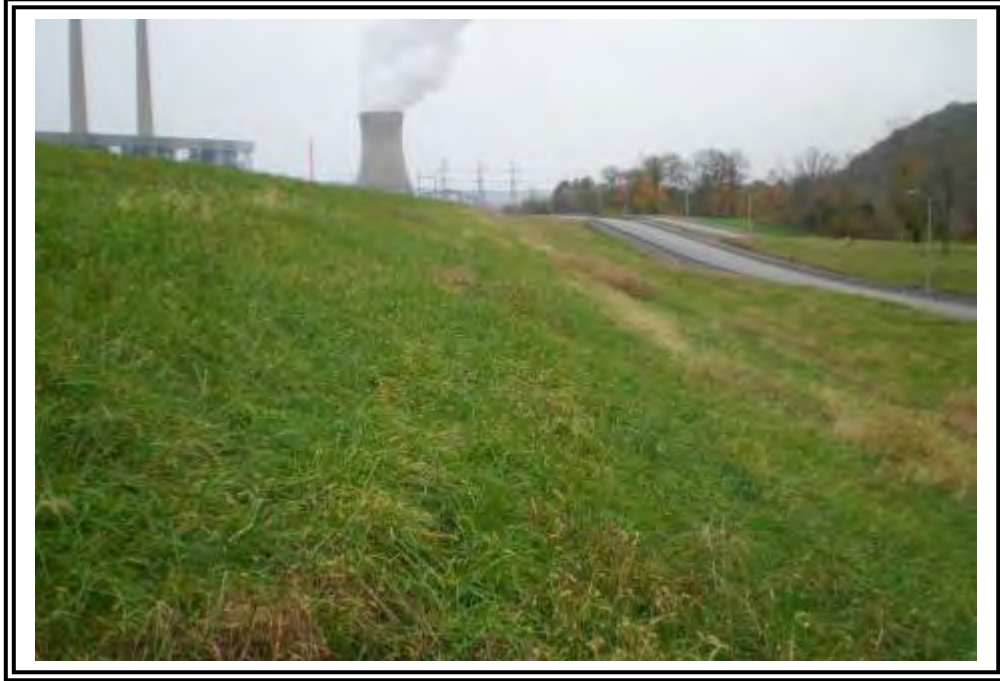
31

Looking southwest along the downstream slope of the northern dike.

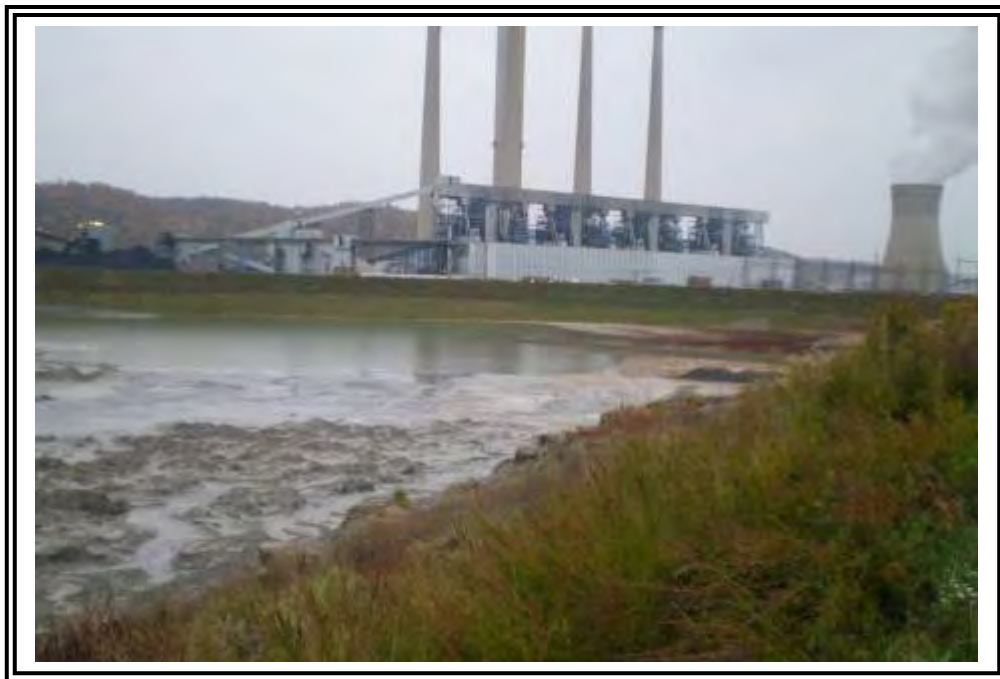
32

Looking southwest along the upstream slope of the northern dike.

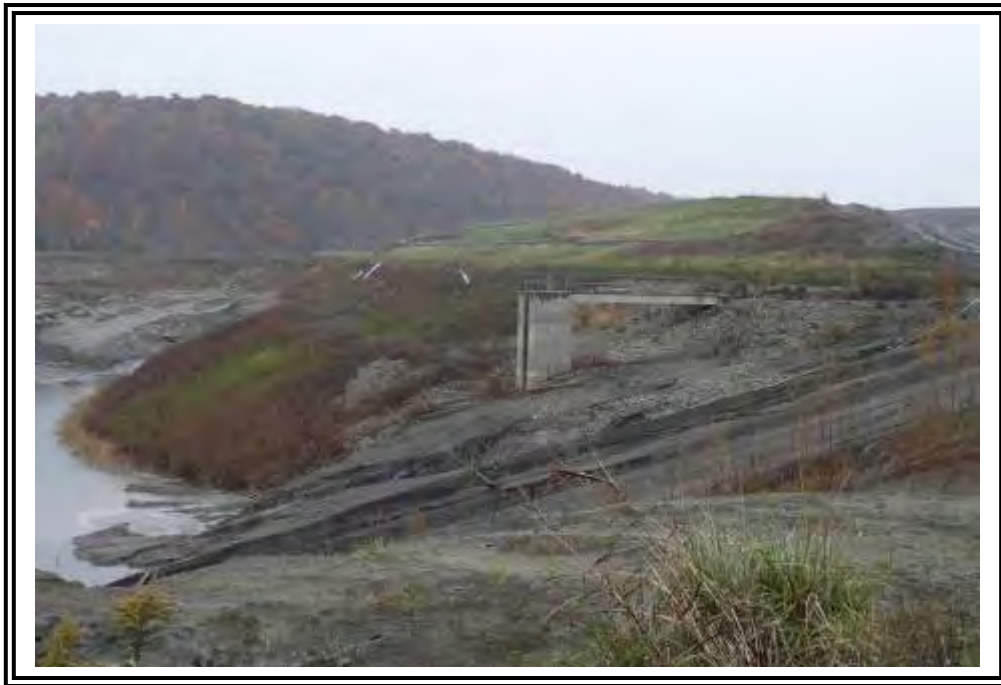
33

Looking north across pond back toward the outfall structure and truck ramp.

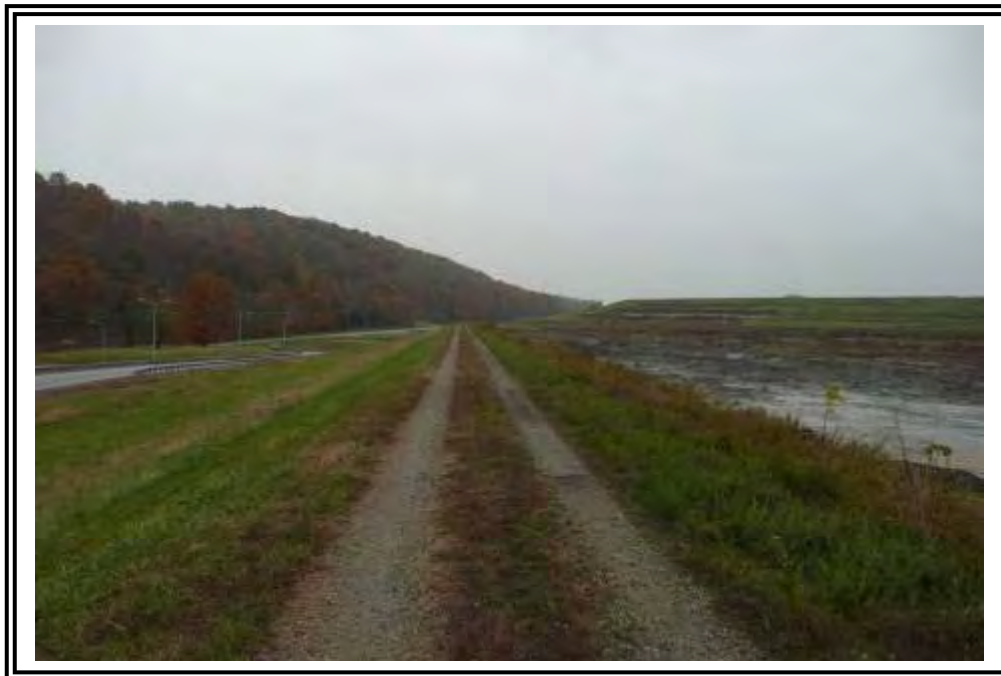
34

Looking northeast along the crest of the northern dike.

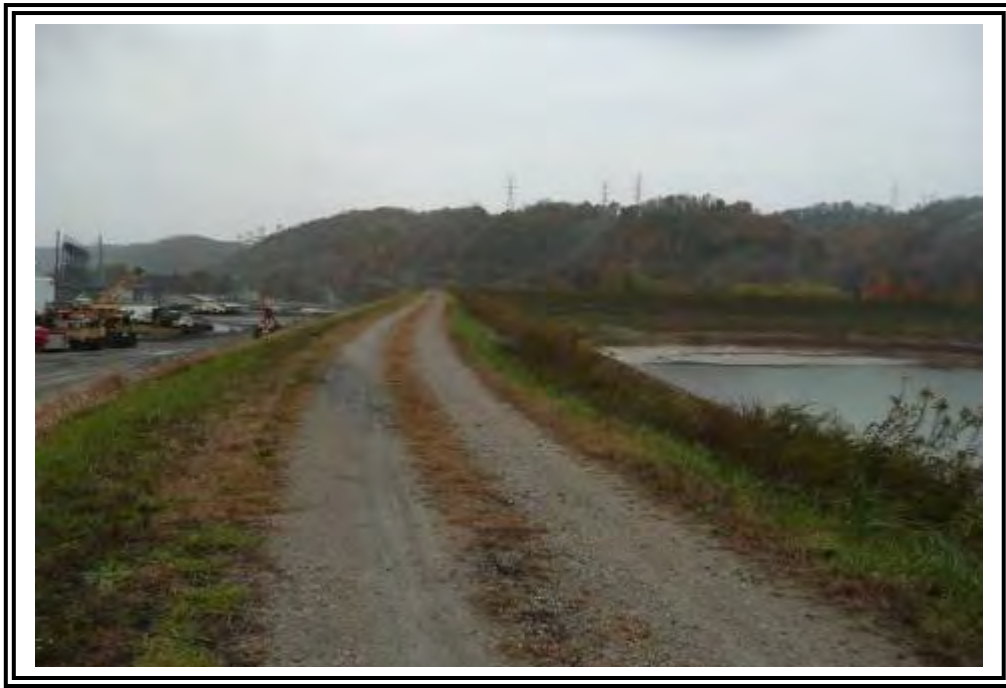
35

Looking northwest along the crest of the southwest dike.

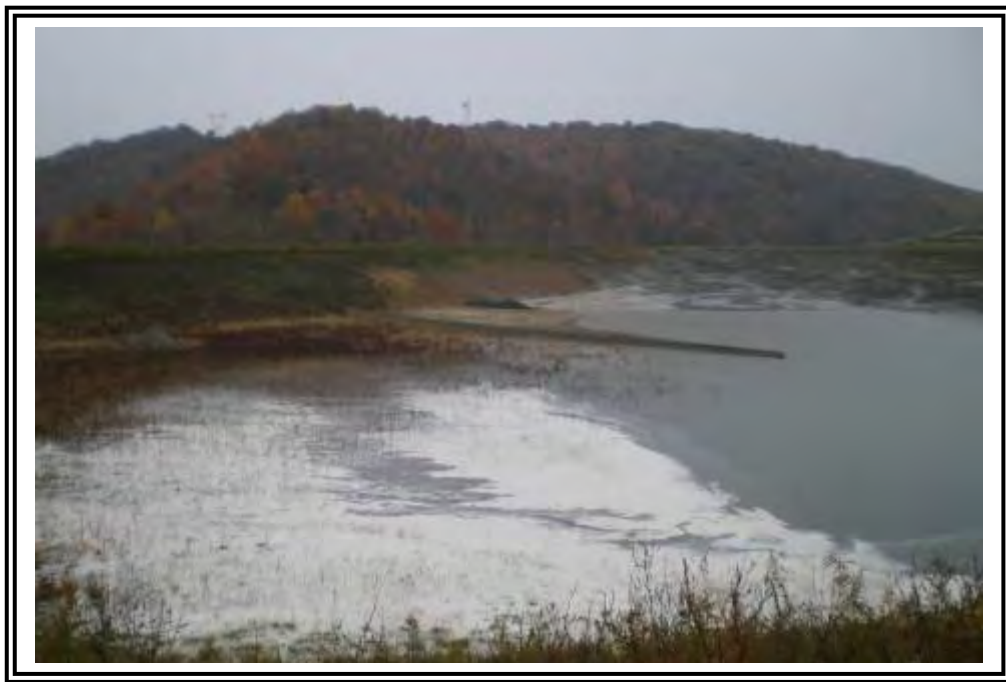
36

Looking northwest across Pond 10.

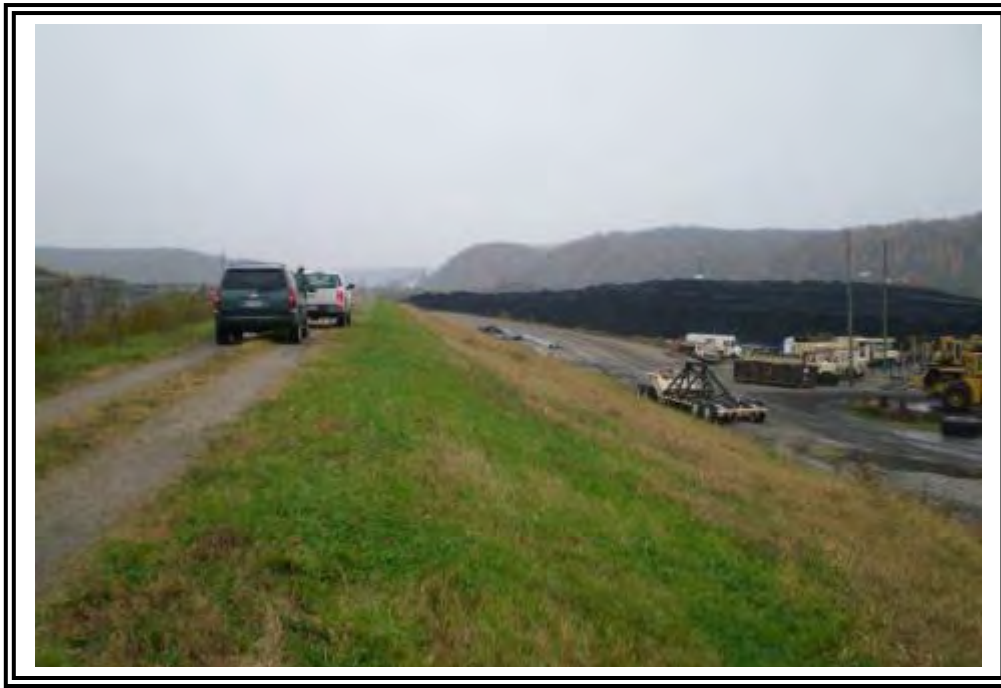
37

Looking southeast along downstream slope and crest of southwestern dike.

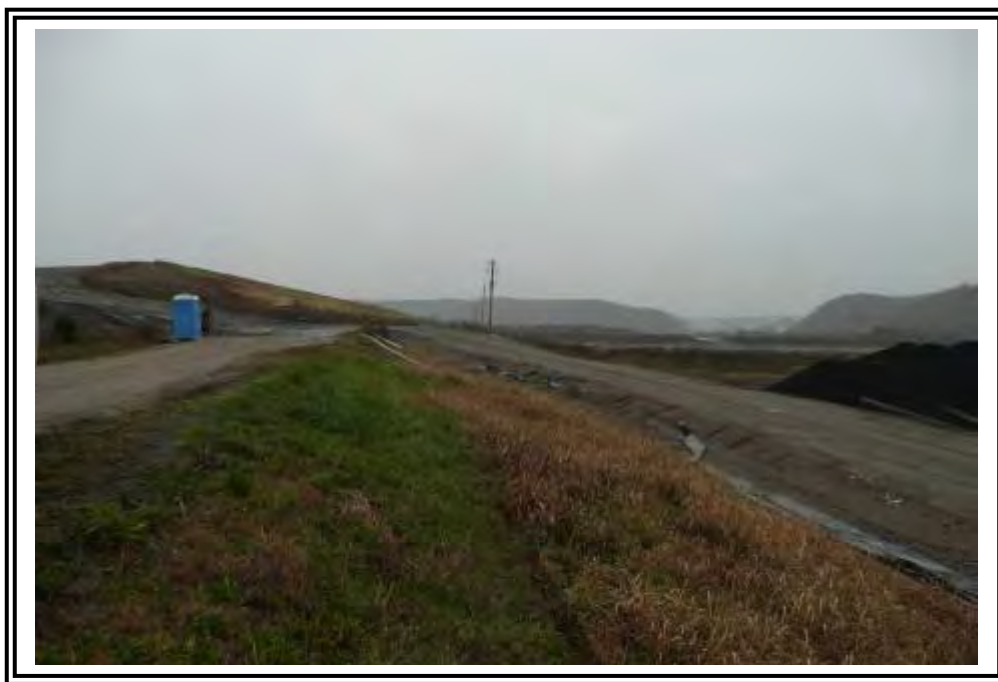
38

Looking southeast at downstream slope and crest of southwestern dike at the southeast corner.

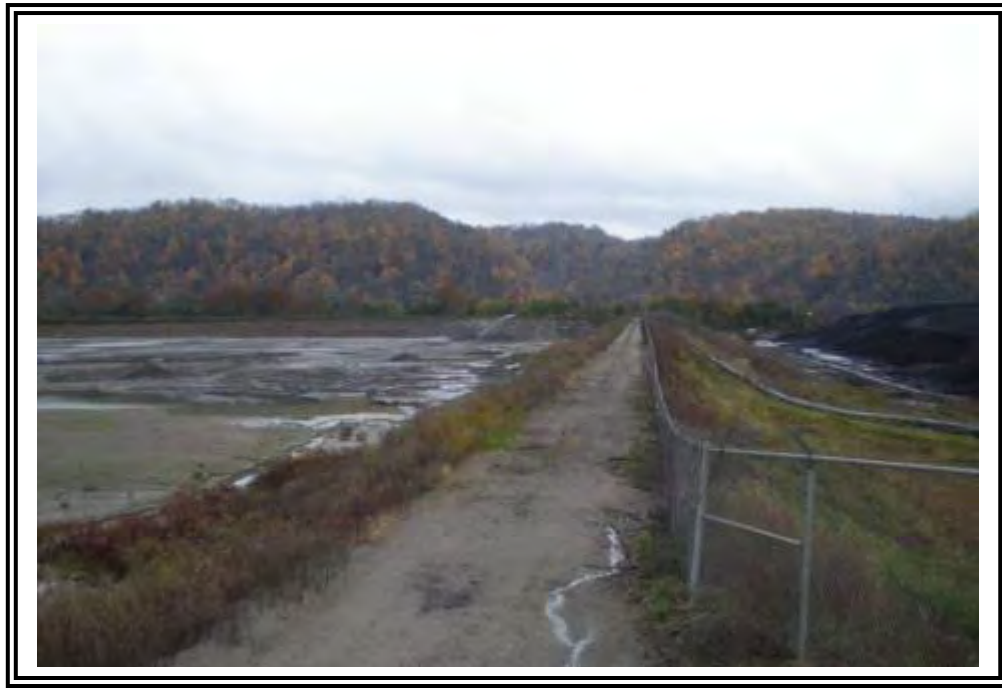
39

Looking south along the western dike crest of Pond 3A.

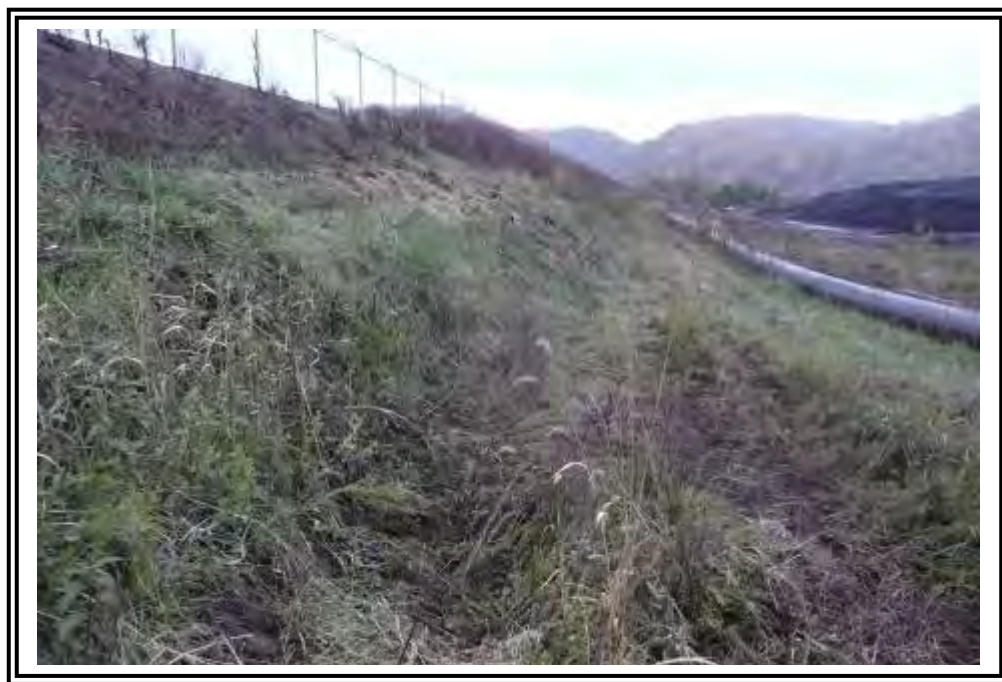
40

Looking south along the downstream slope at over-steepened area of the west dike of pond.
Note sluice pipe near dike toe.

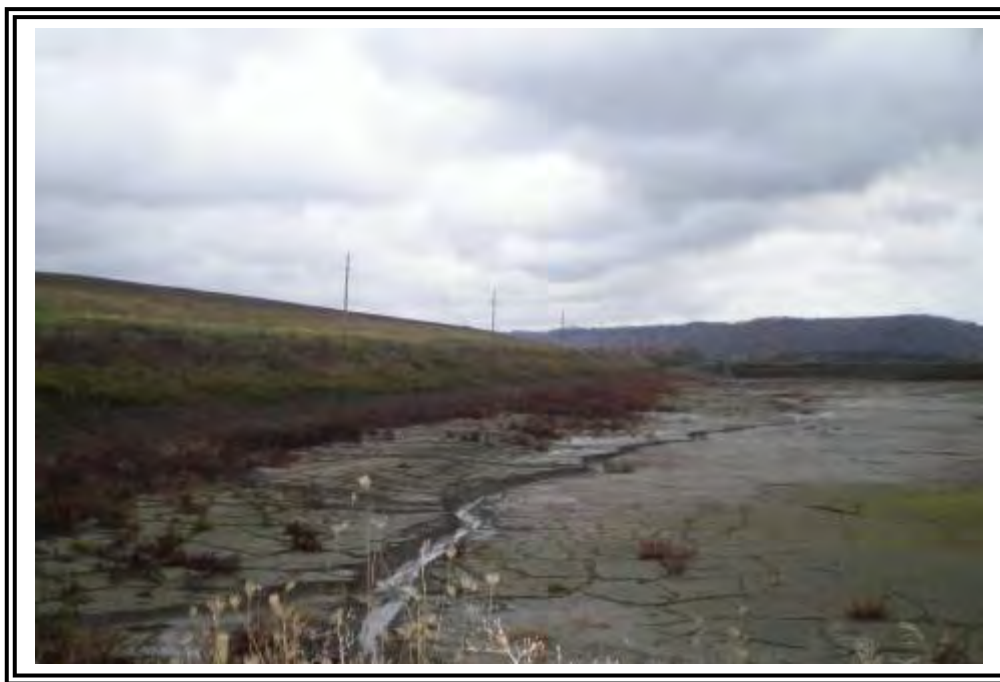
42

Looking east at upstream slope of the north dike of the pond.
There is some beaching just above the ash line on the upstream slope.

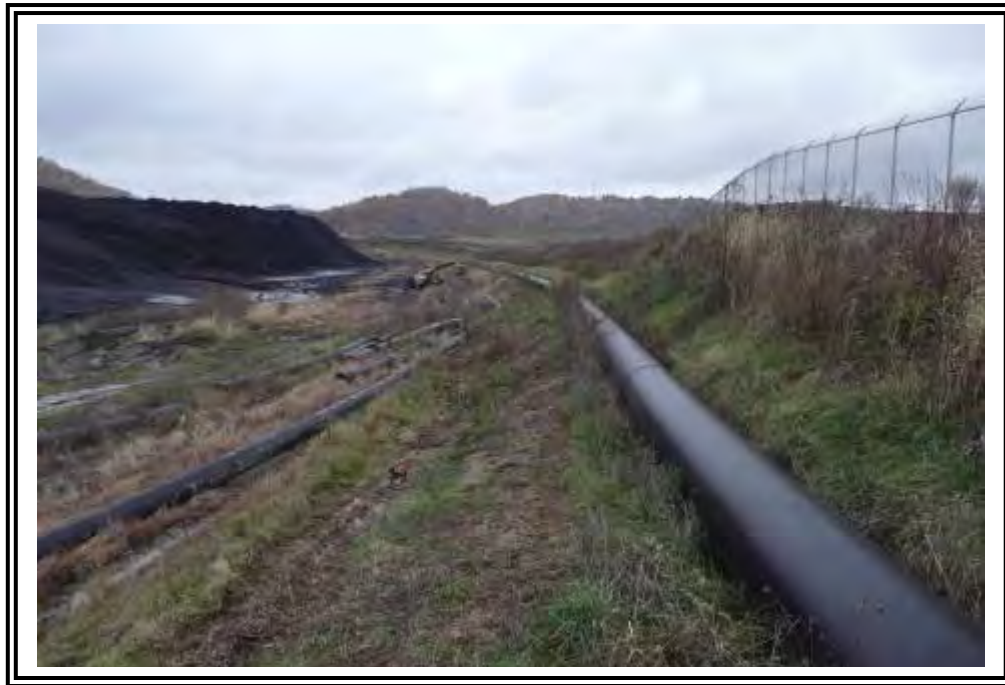
43

Looking north along the downstream slope of the west dike from the south end. Note sluice pipe on slope.

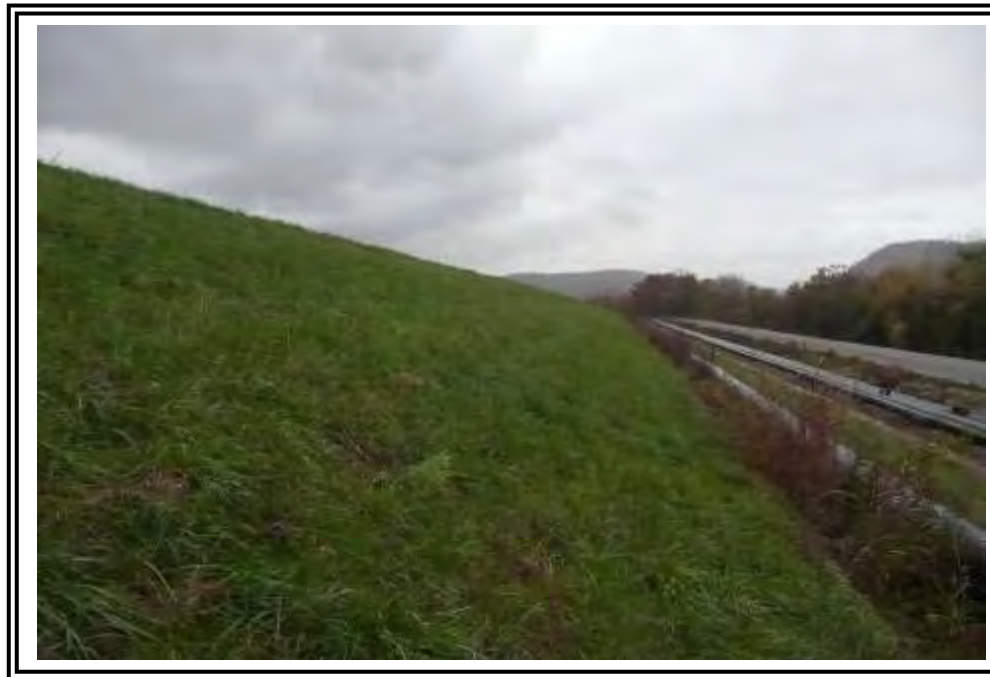
44

Looking east along the downstream slope of the south dike. Inactive sluice pipe in bench is visible at dike toe.

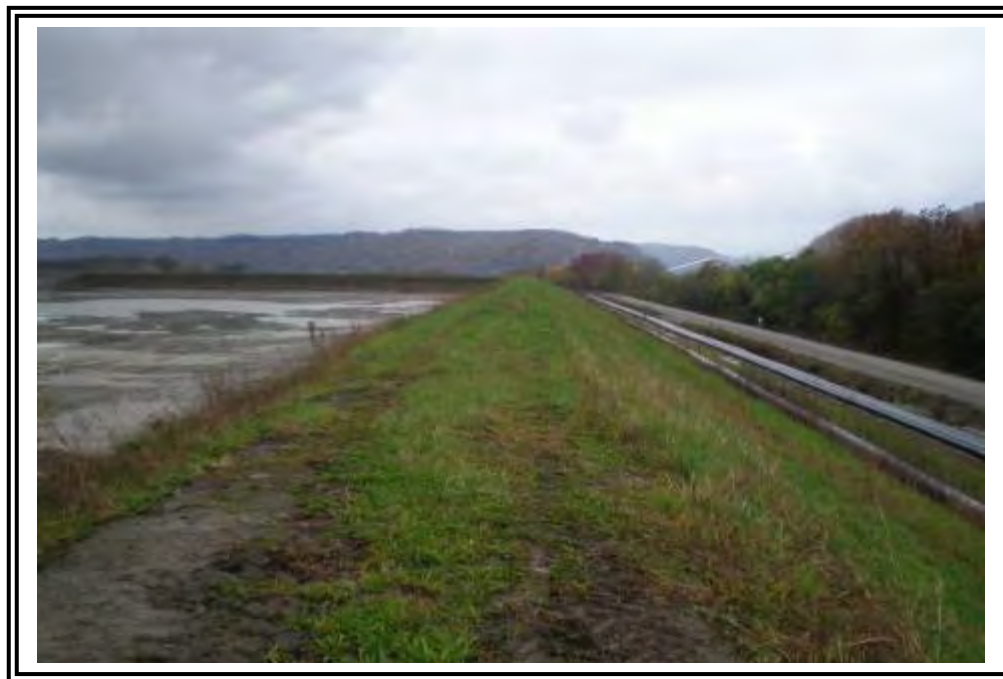
46

Looking east along the crest of the south dike.

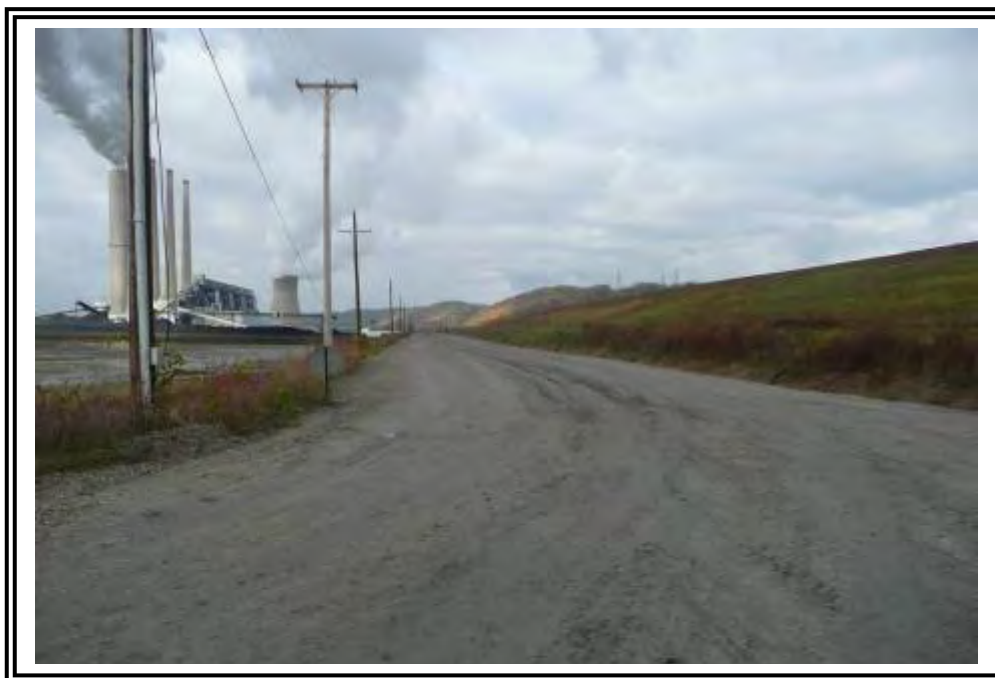
48

Looking west along the road on the north dike. Landfill 11 is shown on the right side of the photo.

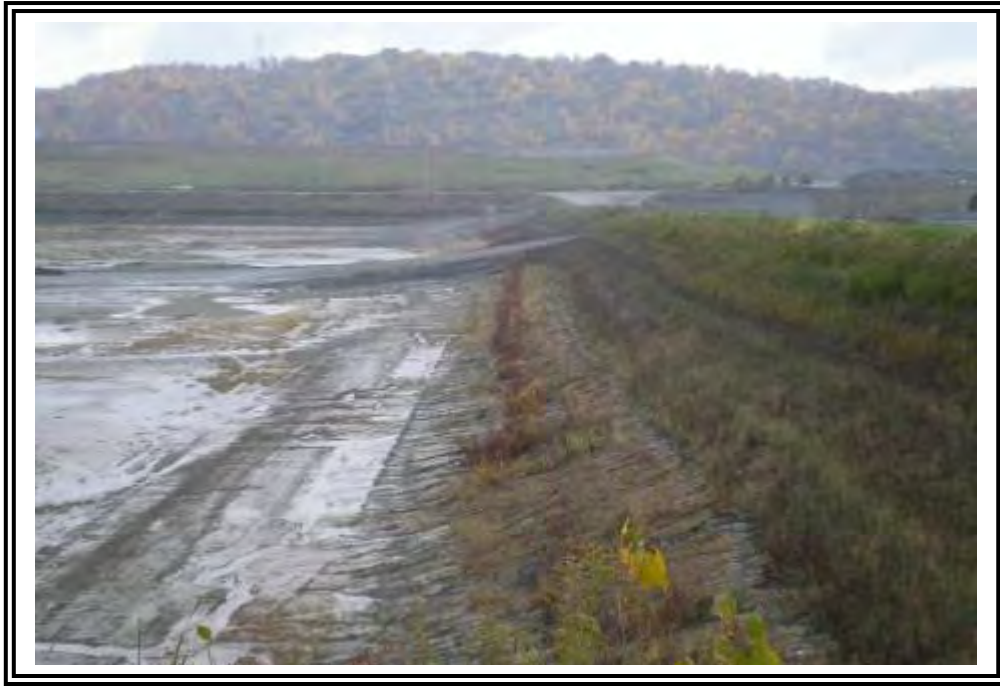
49

Looking north along the upstream slope at the east dike of Pond 3A.

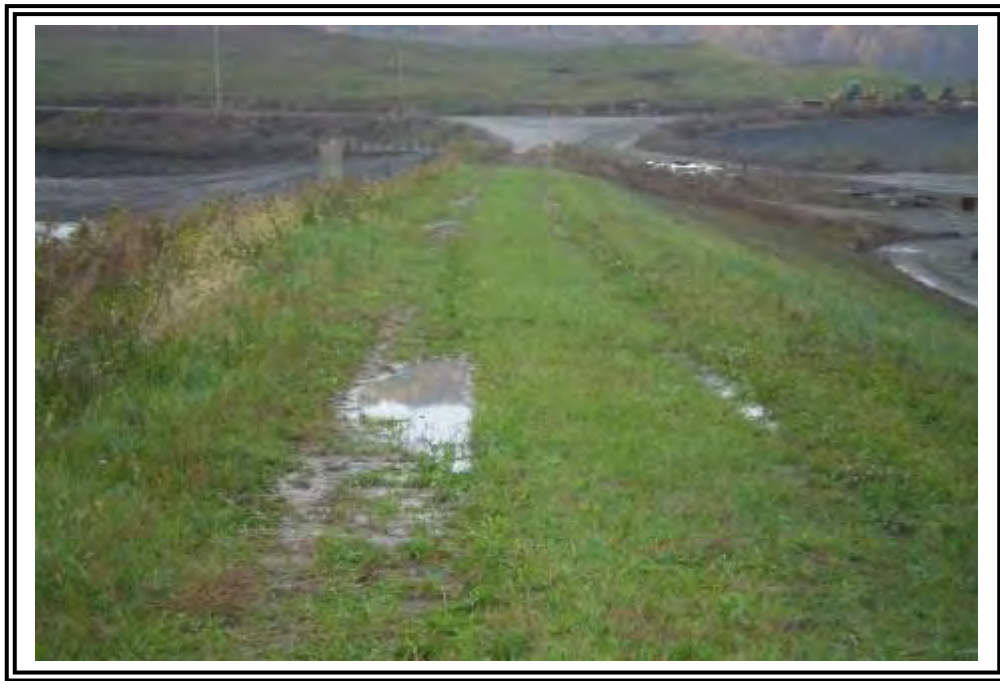
50

Looking north along the crest of the east dike.
The outfall structure is in the background near the northeast corner of the pond.

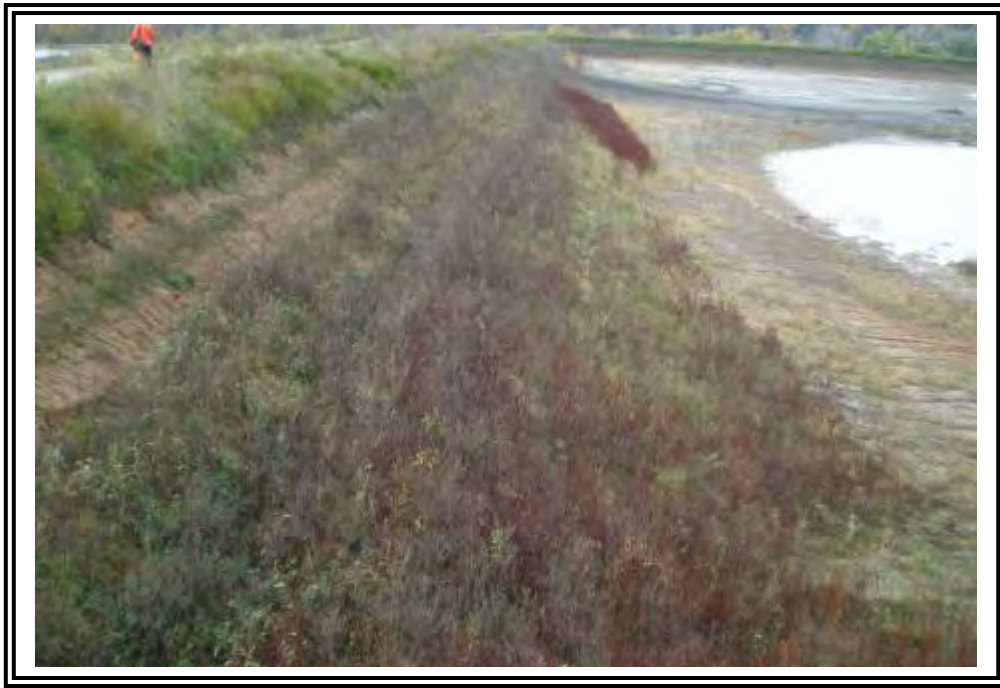
51

Looking south along the upstream slope of the east dike from the north end.

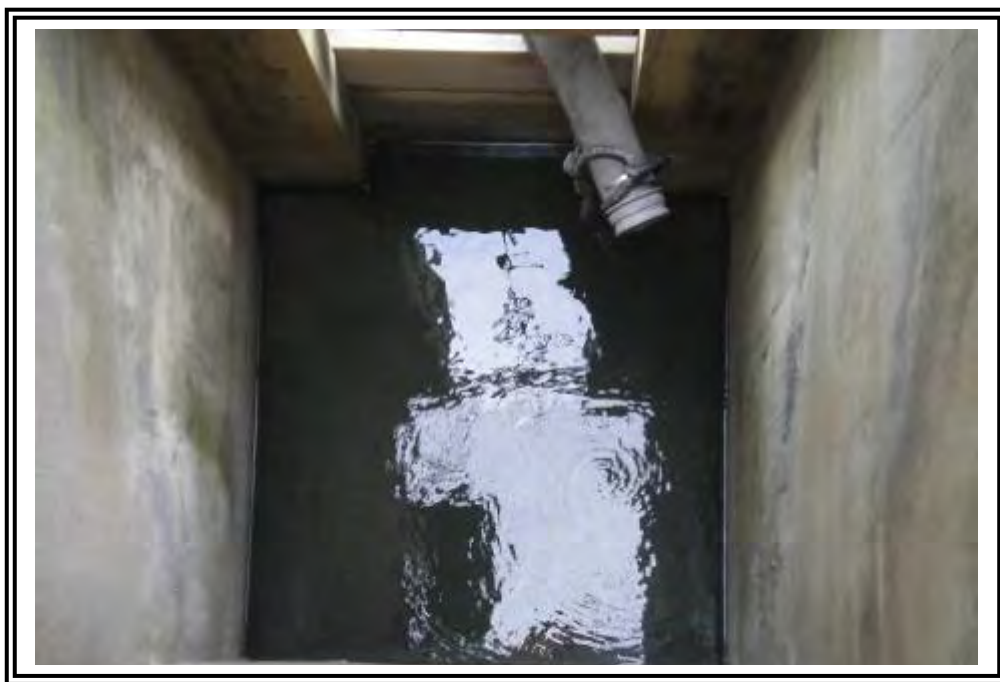
52

Close up of inside the outfall structure.

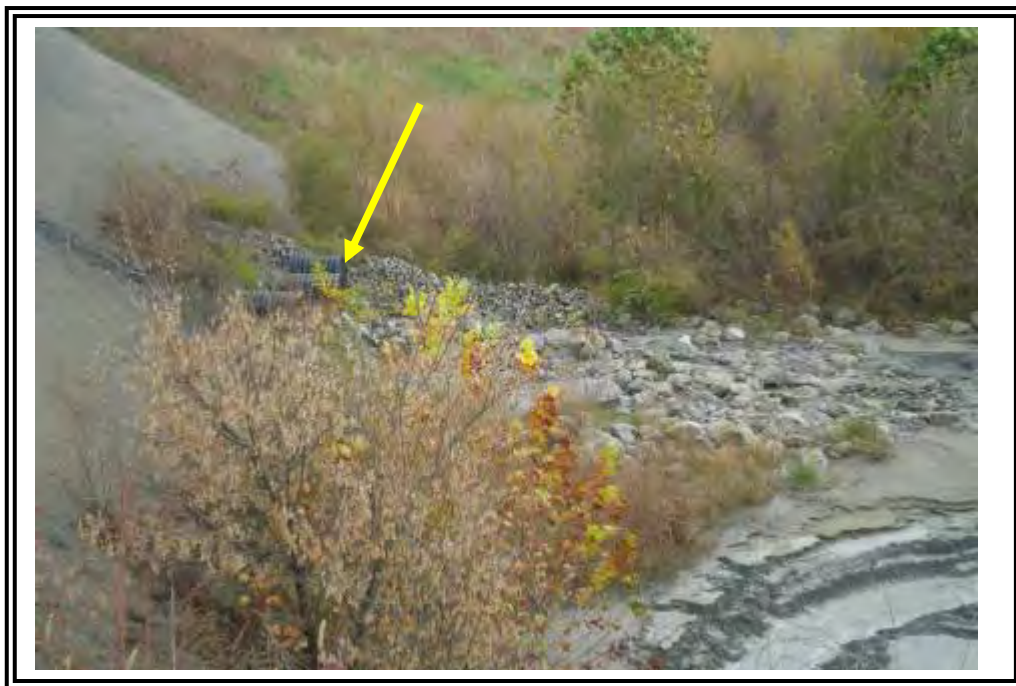
53

The leachate and stormwater collection pipes from Landfill 11 beneath western dike wall of Pond 6, looking north.

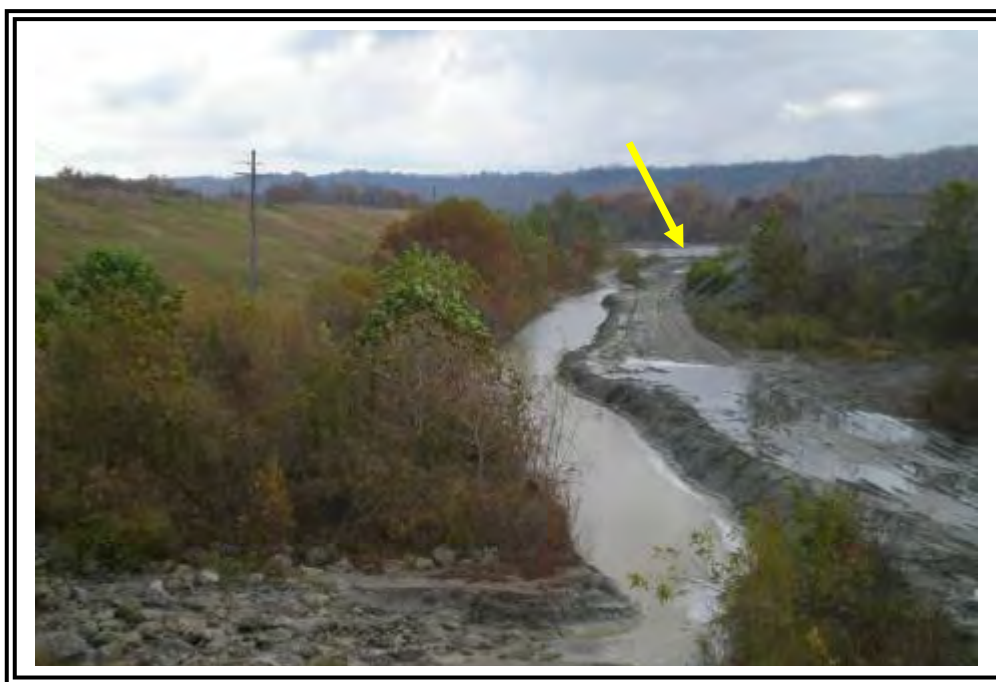
54

Looking east at the discharge channel that conveys effluent from Pond 10 and Pond 3A into Pond 6. Open water in Pond 6 is in distant background (see arrow).

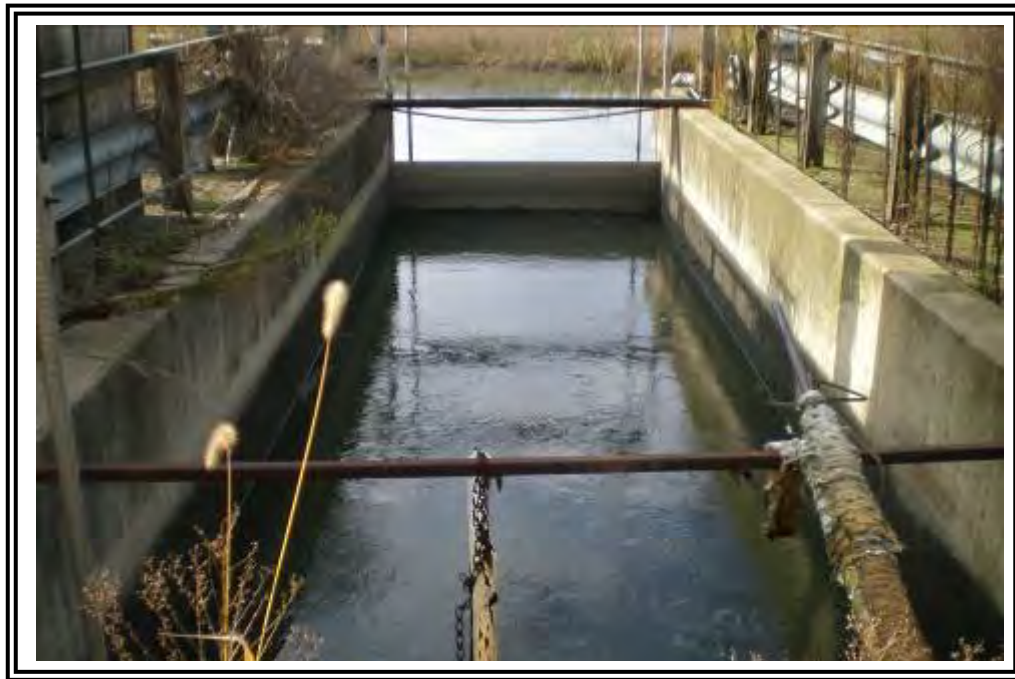
55

Pond 6 outfall structure at the northeast corner of the pond.

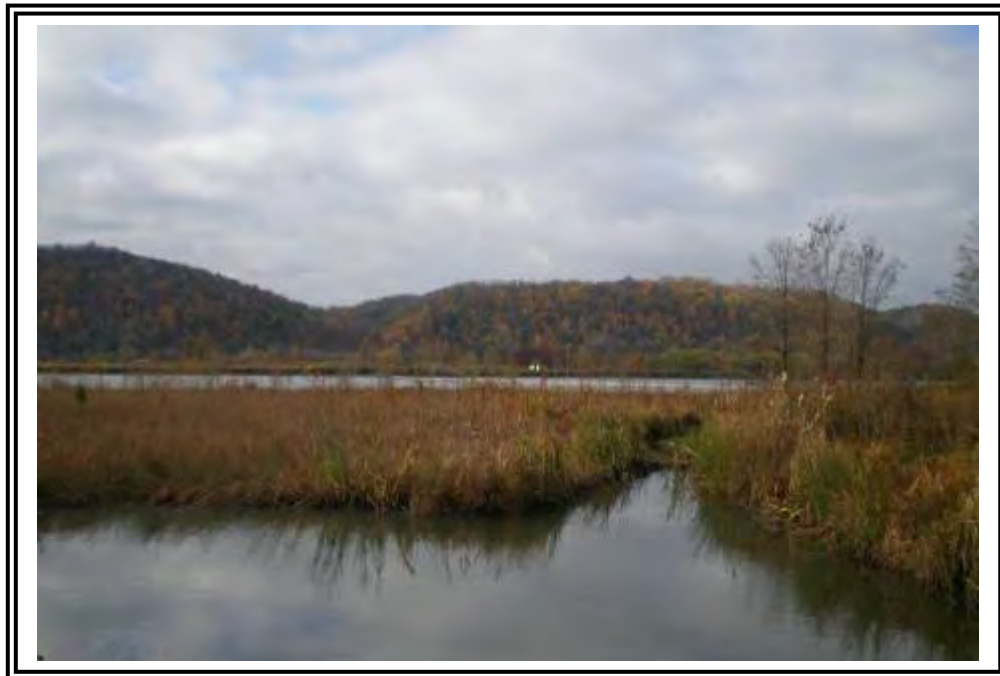
56

The north wall of the pond appears to be at the approximate foundation level for Landfill 11 (formerly Pond 8) as seen in Photo 61. This area is moderately to heavily vegetated with weeds, grasses, brush, and smaller trees (Photos 56, 57, 59, and 62). The pond level was down slightly during the site visit, and some beaching erosion was visible as noted in Photos 58 and 59. Standing water was also encountered intermittently in this area (Photo 60), but this was likely due to the recent rains, sheet-flow runoff from the landfill, and the fairly flat topography in the area between Pond 6 and Landfill 11.

Looking southwest across Pond 6 from northeast corner adjacent to Pond 6 outfall.
